Metallurgical Failure Analysis of Power Transmission Components

Craig J. Schroeder

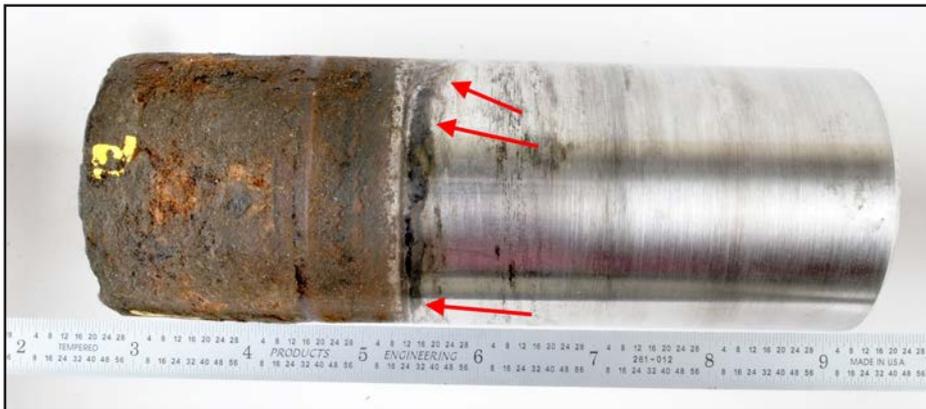
Figure 1 Fractured shaft, as received. Yellow marking indicates 12 o'clock position arbitrarily identified by Element New Berlin. Arrows indicate fretting damage.

and 2. The yellow markings were made by Element to identify the 12 through 9 o'clock positions on the shaft. Markings such as these can prove invaluable in the course of an investigation to help orient the analyst and communicate the findings, especially after the part has been excised for further testing and analysis. It is obvious that the fractured end of the shaft, at the left portions of the images, was severely corroded. The arrows in the photographs indicate the presence of non-uniform fretting damage, suggesting that the fit with the bearing and the loads that were applied to the shaft were non-uniform. Although the fretting damage was located away from the fracture, it provided clues about the non-uniformity of the bearing fit and the loading on the part. This non-uniformity can lead to vibration and bending stresses on the shaft that can contribute to the failure of the part.

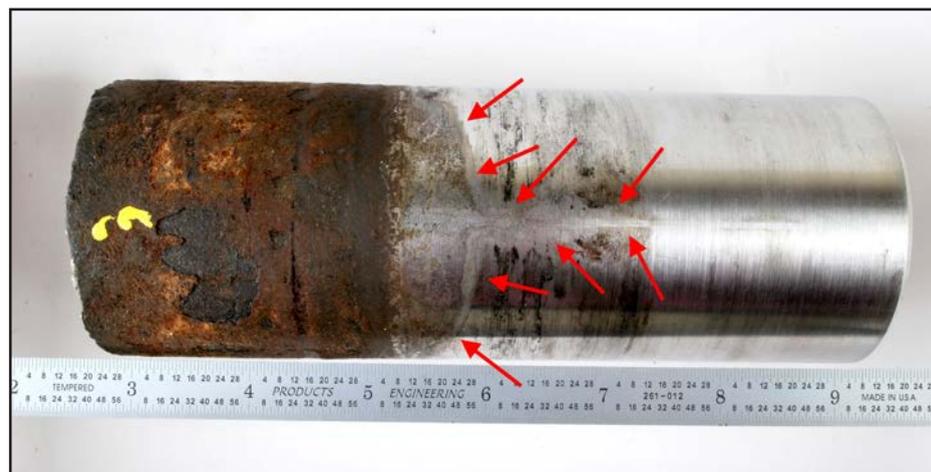
Figure 2 Three o'clock position of shaft after rotating piece 90°. Arrows indicate pattern of fretting damage. Pattern of fretting damage suggested non-uniform contact on bearing. Pattern at 3 o'clock position indicated region of non-contact when bearing was present.

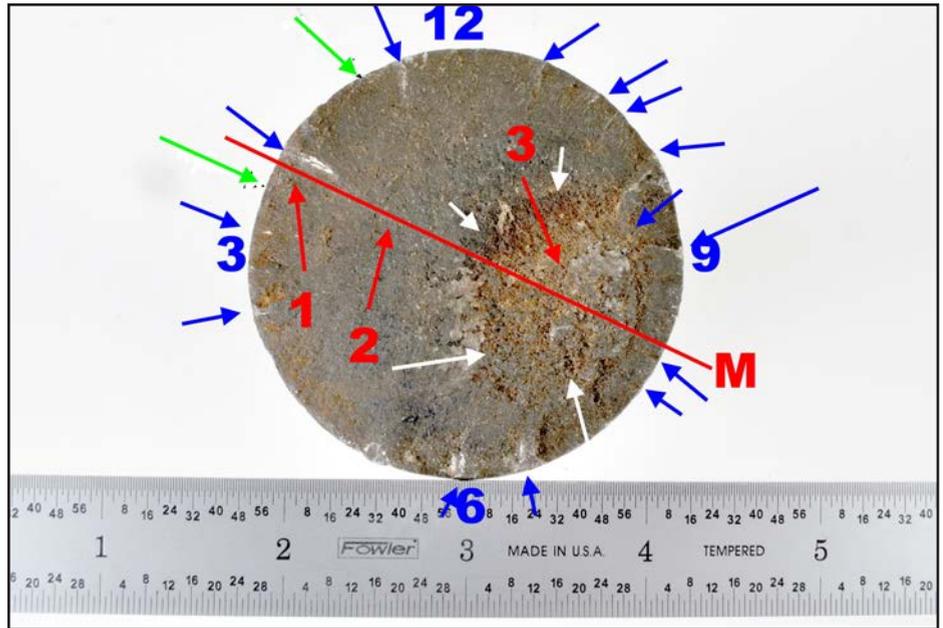
The fracture surface of the shaft is presented in Figure 3 after rotating the piece relative to Figures 1 and 2. The white arrows indicate the final fracture region. The final fracture region often consists of a rough texture or shear lip. The green arrows indicate the primary fracture origin region, which was judged to be approximately 180° away from the final fracture region. The blue arrows indicate ratchet marks. Ratchet marks are linear features, indicative of intersecting crack planes and are commonly present on fatigue-related fractures with multiple origins. As the blue arrows indicate, there were many fracture origins present around the circumference of the shaft. Ratchet marks are also associated with high stress concentration. The red arrows indicate the locations selected for further analysis via SEM-EDS. Section M was selected for metallographic analysis. It's critical for the analyst to carefully document, record and identify the features of the failed part and the damage present on the failed part in its as-received condition. The failed part will be handled, excised and examined in the laboratory. It can be critical to know the condition of the part, as-received, as the part can be damaged and sectioned during the investigative process.

Figure 3 Fracture surface (Fig. 2, left). White arrows indicate final fracture region. Blue arrows indicate ratchet marks. Green arrows indicate fracture origin region. Red arrows indicate locations selected for further analysis. Section M selected for metallography.

- The fracture of the shaft was judged to be due to a combination of cyclic stresses that exceeded the fatigue strength of the part and corrosive attack that potentially initiated the cracking, but also accelerated the rate of cracking. This type of cracking is also known as corrosion fatigue. Although most of the original fracture features on the surface of the part were obliterated by corrosion damage, ratchet marks, indicative of intersecting crack planes and high stress concentration, were evident on the fracture surface. Ratchet marks are characteristic of fatigue-related cracking. Substantial corrosion products were present along the outer diameter of the shaft.

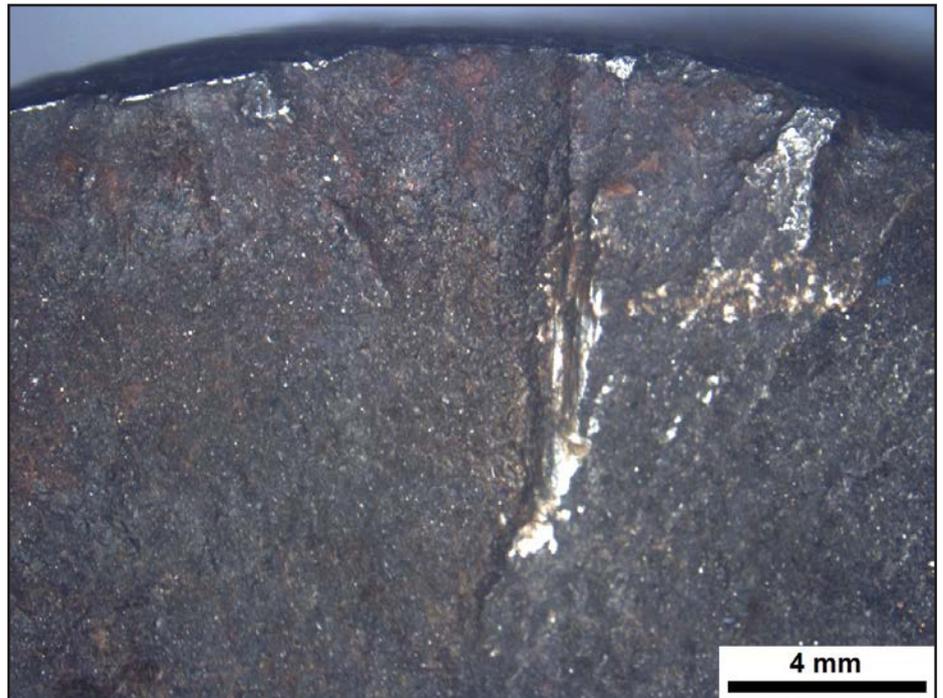
Figure 4 Magnified view of origin region (Fig. 3, top left), Location 1. Post-fracture mechanical rubbing damage, along with black and orange corrosion deposits, are evident in this view (original magnification (OM) 6×).

low-power stereomicroscopy reveals a relatively rough texture with a notable amount of corrosion deposits and post-fracture mechanical rubbing damage, as shown in Figure 4. Inspection of the fracture and other features via electron microscopy is often the next step in the failure analysis process. Scanning electron microscopy is often utilized by the analyst to verify the fracture mode as features visible with a low power bin-

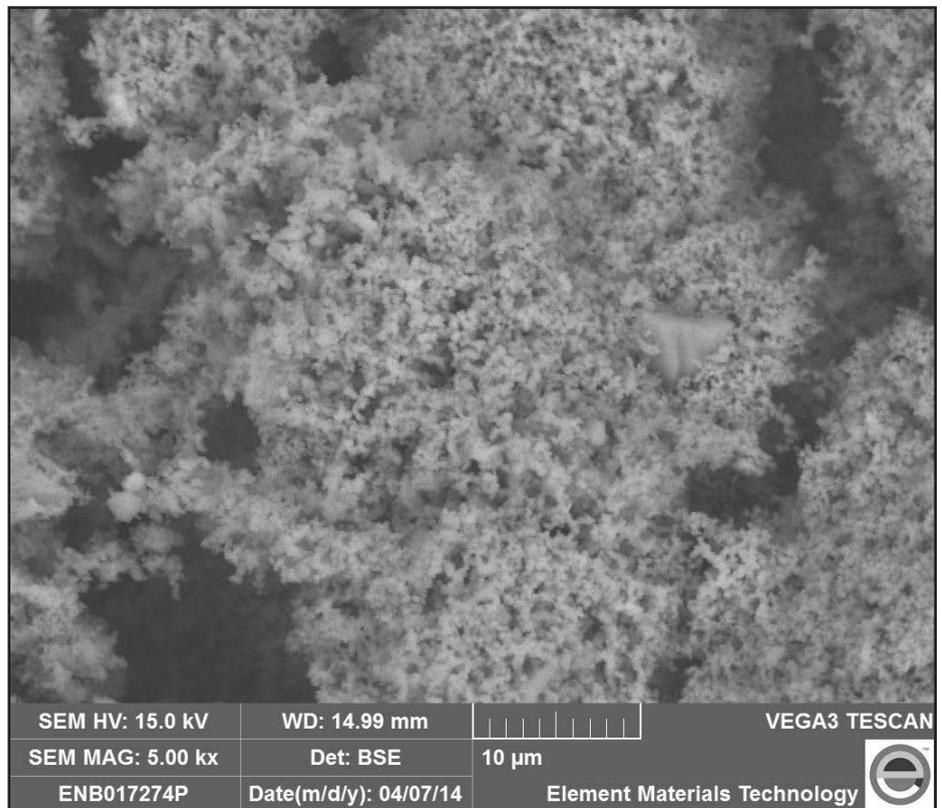
The corrosion deposits obscured the original fracture features, even after the piece had been gently cleaned. Location 1 is presented in Figure 6 after additional cleaning. The features detected beneath the corrosion deposits had the appearance of corrosive etching, indicating the shaft was present in a severely corrosive environment. The features in Figure 6 had a texture similar in comparison to pearlite lamellae, indicating the location shown had been etched.

In addition to the base metal elements, the EDS detected manganese, aluminum, sodium, magnesium, calcium, titanium, zirconium, phosphorus, sulfur, carbon and oxygen. The manganese may have been from the base metal. The aluminum, sodium, magnesium, calcium, titanium and zirconium were judged to be present as mineral deposits. The source of the phosphorus was not known, but the presence of phosphorus is often associated with detergents. The source of the sulfur was not known. The carbon was judged to be present as organic or carbonaceous

Figure 5 Scanning electron micrograph of Location 1. Substantial amount of deposits were still present after preliminary cleaning of fracture surface. Features had oxidized appearance.

deposits. The detection of oxygen indicated the presence of oxides or corrosion deposits on the steel. In general, the EDS detected foreign material present as mineral deposits, dirt, and oxidation products. Often, chlorine will be detected on corroded components. Chlorine, in the form of chlorides, is corrosive to steel in a moist, acidic environment. In this case, chlorine was not

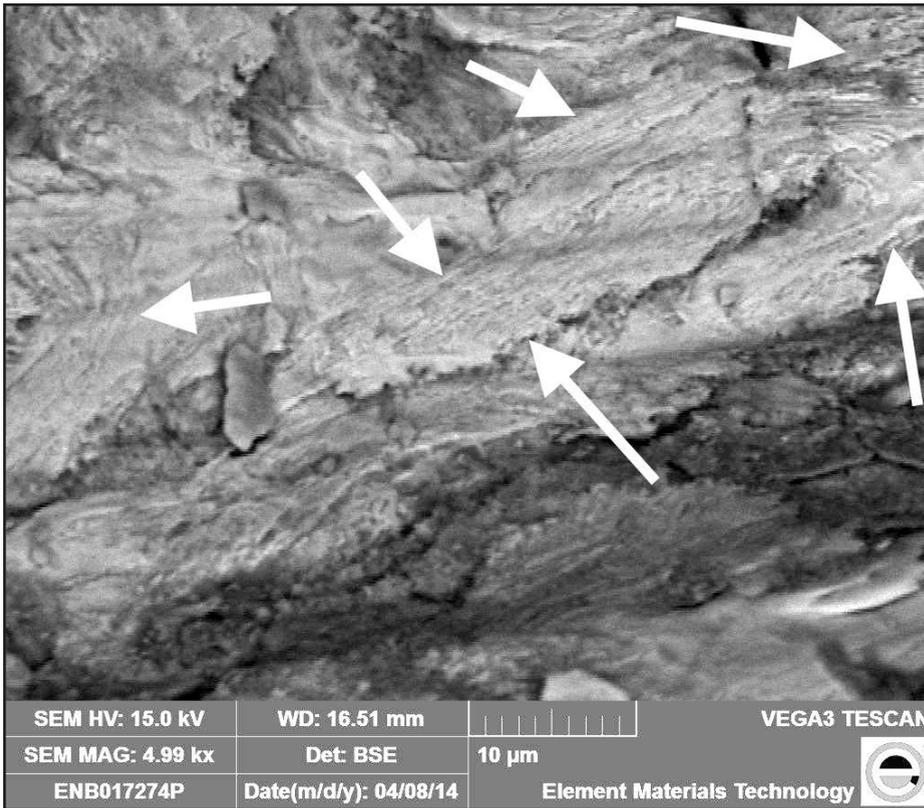
Figure 6 Scanning electron micrograph of Location 1 after additional cleaning. Arrows indicate features with appearance of corrosive etching into the pearlite lamellae on the steel.

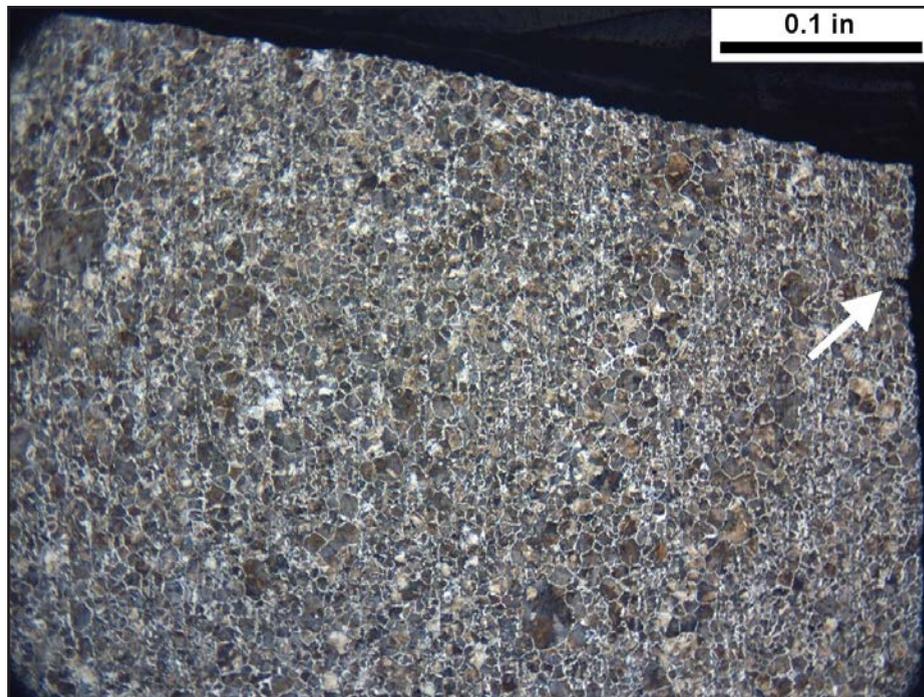
Figure 7 Section M — after etching. The fracture surface is at top portion of image. The microstructure consisted of pearlite and ferrite. The arrow indicates location of feature selected for closer inspection; 2% nital (OM 10×).

the part's performance. In this case the microstructure was judged to be normal for the material of manufacture, as shown in Figures 7 through 9. Some variation in the grain size was evident in the view. The grain structure was

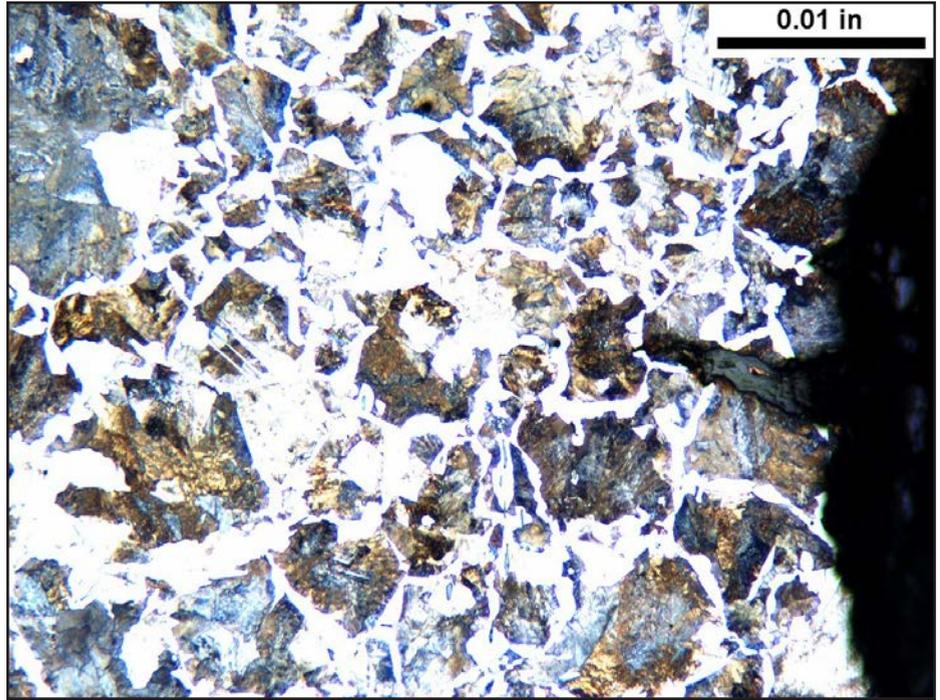
judged not to be a contributing factor in the failure of the part. A higher magnification view of the top right portion of Figure 7 is presented in Figure 8. A secondary crack, indicated by the white arrow, is at the right center portion of

Figure 8 Higher magnification view of the right-center portion of Figure 7, as indicated by the arrow in Figure 7. Secondary crack is evident at right portion of image. Image was overexposed to show crack, indicated by arrow; 2% nital (OM 100x).

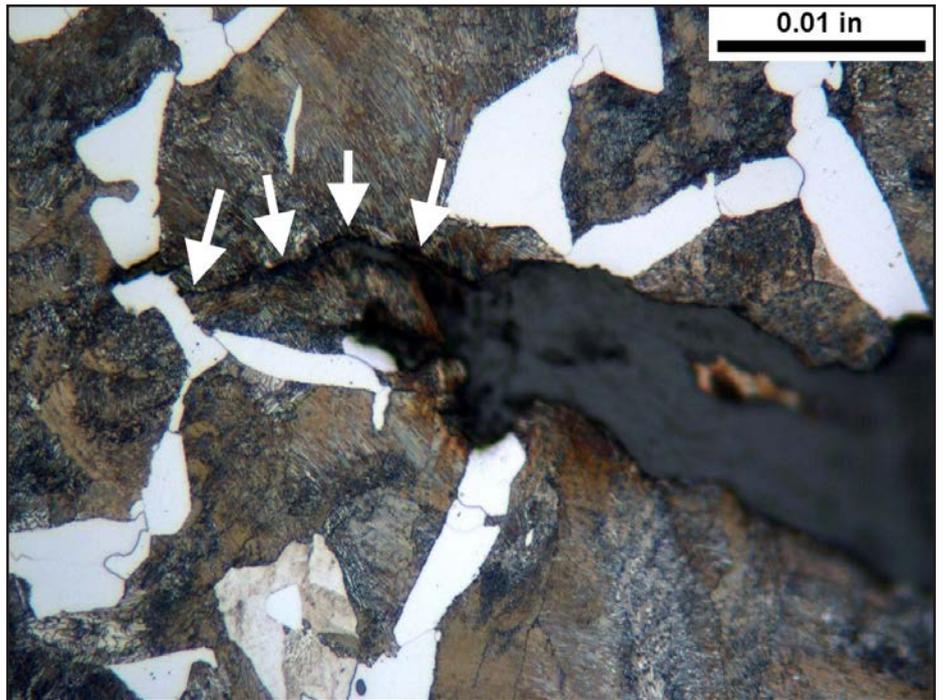
the image. The image was overexposed to show the gray scale that was present in the crack. A higher magnification view of the right center portion of Figure 8 is presented in Figure 9. The arrows indicate the presence of corrosion scale in the tip of the crack. The presence of corrosion scale in the tip of the crack is typical for corrosion fatigue related cracking. Corrosion fatigue can occur to a part due to a combination of cyclic stresses that exceed the fatigue strength of the part and corrosive attack that potentially initiates the cracking, but also accelerates the rate of cracking. Although some of the corrosion present on the part could have formed after the piece had failed, it was judged that corrosion fatigue was the mechanism of failure due to the presence of corrosion scale at the tip of the crack. The microstructure of the shaft otherwise consisted of pearlite and grain boundary ferrite, typical for plain carbon steel in the annealed or normalized condition.

- Metallographic analysis of the shaft revealed the presence of a secondary crack near the fracture origin region. Corrosion scale was present at the tip of the crack. The presence of corrosion scale at the tip of a crack is commonly associated with corrosion fatigue. It was therefore judged that corrosion not only took place after the part fractured, but contributed to the progression of cracking. The microstructure otherwise consisted of pearlite and grain boundary ferrite, typical of plain carbon steel in the annealed or normalized condition.

Figure 9 A higher magnification view of the right-center portion of Figure 8. Arrows indicate the presence of corrosion scale in tip of crack; 2% nital (OM 500x)

Follow on activities, such as a stress analysis of the system, may be in order to help understand remedies to prevent failures from occurring again. Often, a stress analysis in the design of a system may not account for anomalous conditions such as corrosion pitting, non-uniform contact between the bearing and shaft, or mechanisms such as corrosion fatigue. In this case, a stress analysis was beyond the scope of the project. Sometimes, an investigation such as this may be performed in stages, or, budgetary restraints may prohibit certain types of tests and analyses from being performed.
