# Premature Bearing Failures in Wind Gearboxes and White Etching Cracks

Kenred Stadler and Arno Stubenrauch

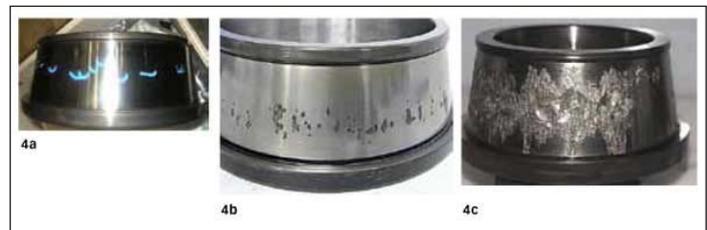
Mostly occurring on the inner ring (Fig. 4), the visual appearance of early cracks varies from straight or “axial cracks” to cracks in combination with small spalls and large/heavy spalling. Based on SKF’s knowledge gained through increased field experience, it is concluded that early failures by cracks are neither linked to a particular type of bearing (Fig. 5), nor to a particular standard heat treatment (Fig. 6; Refs. 6 -10).

Figure 4 Failure appearance: a) straight cracks; b) straight cracks and small spalls; and c) spalls.

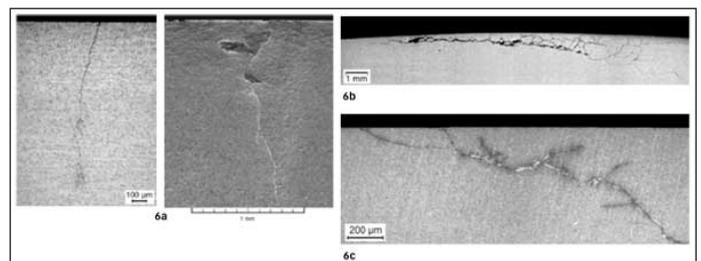
Figure 6 Crack growth patterns in standard heat treatment: a) martensite; b) bainitic; and c) case hardened (case carburized) 6.

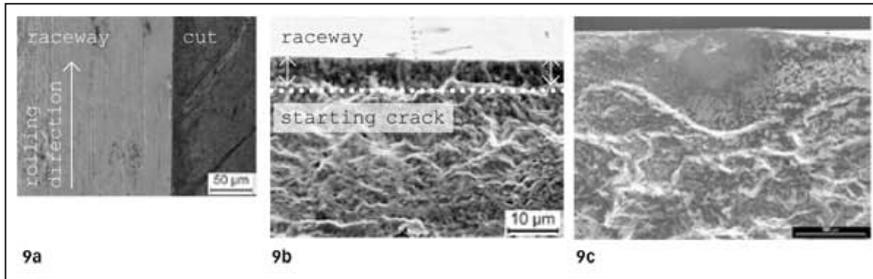
**Figure 9** (A) Small shallow crack at the raceway and further crack propagation, smoothed machining marks indicate potential mixed friction conditions; b) opening of a shallow surface crack; c) surface crack triggered by near-surface inclusion (scanning electron microscope fractographs (Ref. 6).

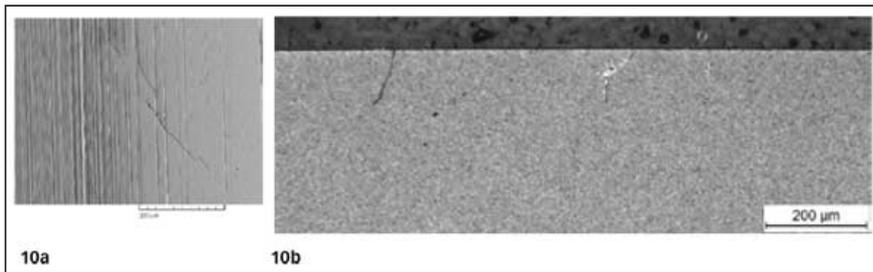
**Figure 10** Cracks on rolling-sliding components from an automotive application: a) small, friction-induced cracks on the raceway—smoothed machining marks indicate mixed-friction conditions; b) circumferential microsection (SKF Material Physics, Schweinfurt) showing a non-decorated crack (left) and white etching-decorated crack (right).

The cracks shown in Figs. 10 and 11 are generated in an automotive rolling-sliding contact at high traction and contact pressures, similar to potential wind load situations of around 3 GPa18.

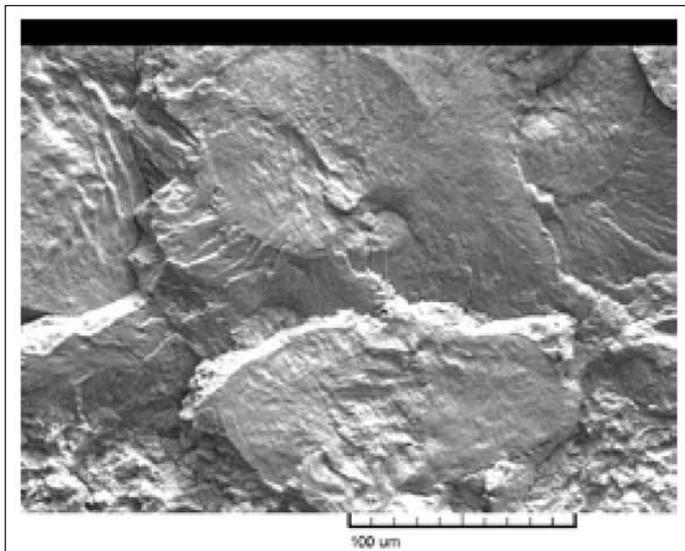
**Figure 11** Opened fracture face (cf. Fig. 10a) revealing two cracks (similar to Fig. 9c), surrounded by the CFC structure (scanning electron microscope fractograph, backscattered electron mode).

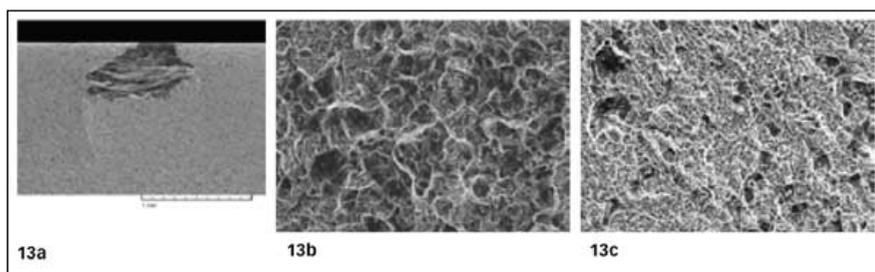
Figure 13 Axial opening of a crack connected to the surface, b) intercrystalline microstructure close to the crack system, c) transcrystalline microstructure elsewhere.

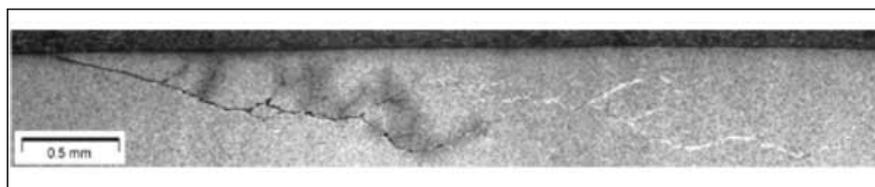
Inside the crack system, the mechanism of CFC will then transform the microstructure locally into white etching areas and lead to the typical appearance of an irregular WEC network (e.g., Figs. 2, 6, 14). Thus, WECs are considered as secondary; a by-product of the CFC mechanism, as the hydrogen released and energy dissipated at the crack flanks result in a local change of the microstructure then appearing as a white etching crack decoration.

Figure 14 Irregular white etching decorated crack network (Ref. 6).
