The Hidden Cost of Incomplete Hydrodynamic Bearing Maintenance

Will Cannon, Application Engineer, Baldor Electric Company

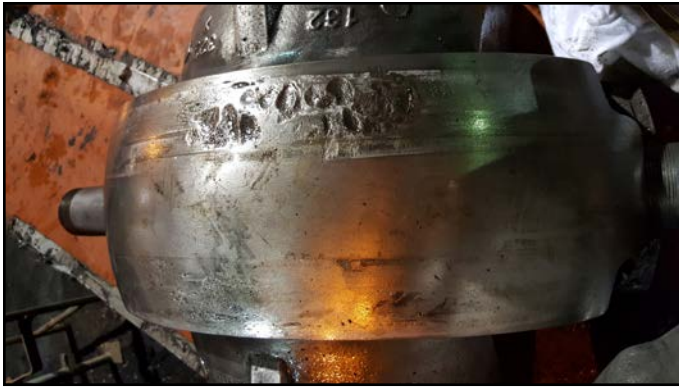
Figure 2 A new liner installed into an old housing failed after ~1 to 1½ years of operation and caused an unexpected fan shutdown due to high vibration levels. The deep pitting and fretting corrosion caused by improper seating of the liner in the housing can be clearly seen.

Performing bearing liner maintenance but neglecting the housing damage from wear and fretting corrosion could consign a new bearing liner to ~1-2 years of life before high vibration issues develop and potentially cause fan shutdown times, which is ~1/10th of the intended life of the liner with proper maintenance and servicing. In an actual example from the field (Fig. 2), a distributor reported: “The customer replaced the liner assembly with a new one approximately 1 to 1½ years ago because of high fan vibration. The fan is again out of service for high vibration”. However, this customer is not unique in this situation of replacing a new liner into an old housing as a standard maintenance procedure

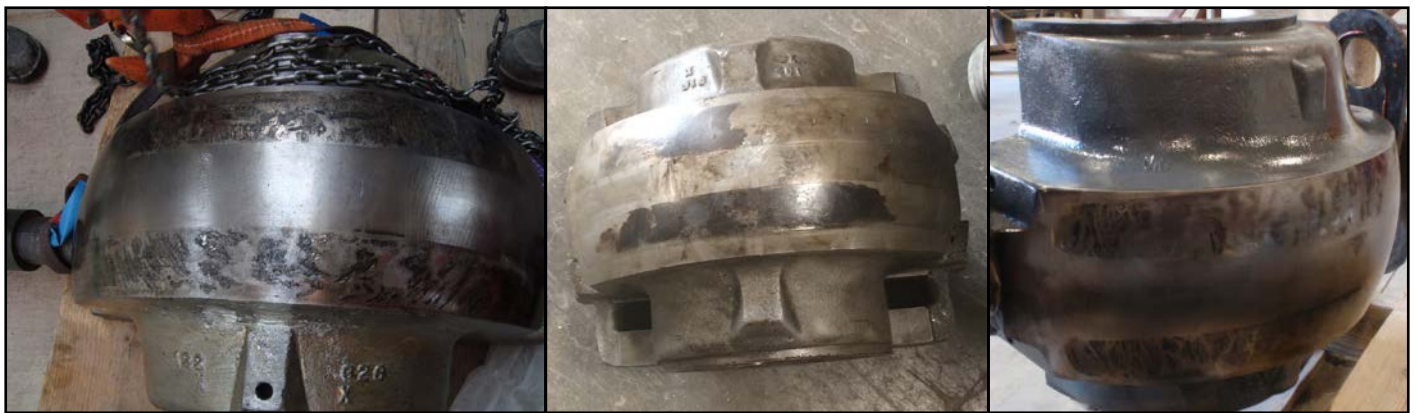
To further demonstrate the common occurrence of this problem, additional pictures from customers across the United States have been included that show the distinguishing marks of fretting corrosion (irregular dark-colored patterns and cavities) along both the liner sphere and spherical seats of the housing (Fig. 3-4).

Figure 3 Three separate liners that have failed due to high fan vibration levels and show the fretting corrosion marks along their spherical seats.

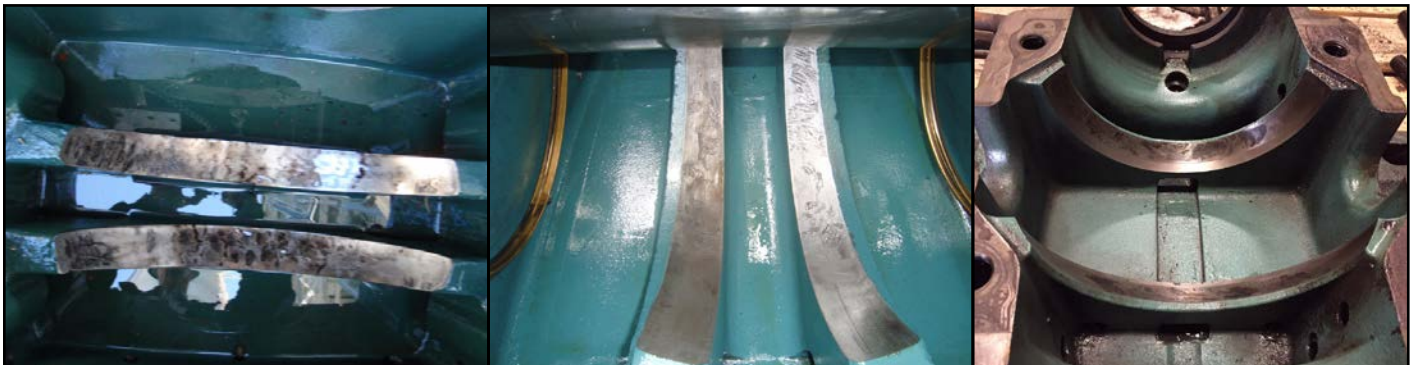
Figure 4 Three separate housings that have been pulled from service due to high fan vibration levels and exhibit the characteristic fretting marks caused by improper contact and retention of the liner within the housing.
