Development of an Actuator

FOR AMBIENT TO CRYO APPLICATION

*(Proceedings of the 40th Aerospace Mechanisms Symposium,
NASA Kennedy Space Center, May 12–14, 2010)*

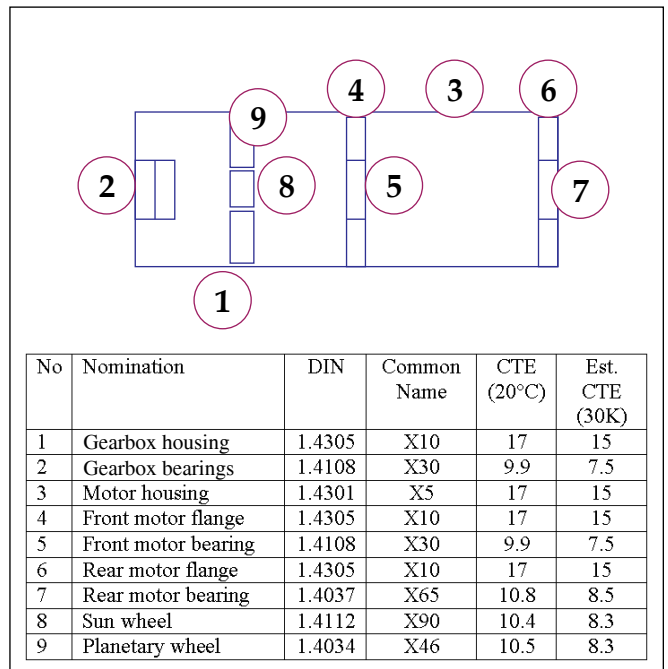
Figure 2—Material concept of first actuator.

The first RMA actuator consisted of a material mix of six different sorts of steel with an estimated COE (common operating environment) at 30K, varying between 7.5×10^{-6} 1/K (ball bearings) and 15×10^{-6} 1/K (gearbox housing). This design was based on experience in gearbox development for usual applications—every single material has its specific strength playing on the individual function. But this cryogenic application cannot be called usual, and different strategies must be pursued.

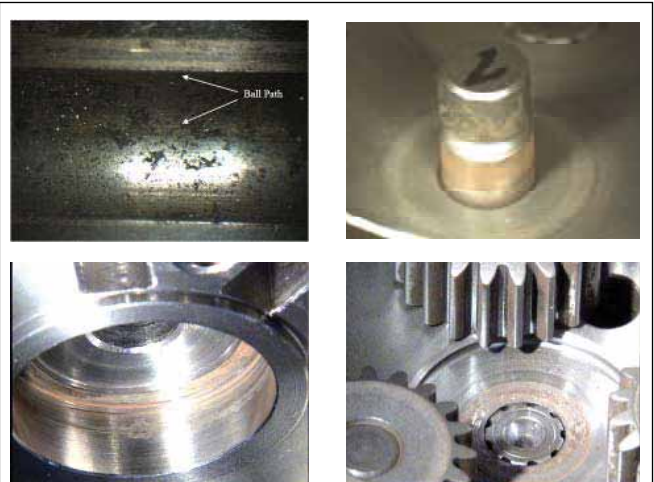
Figure 3—Lubrication failure of first actuator after life test. Visible corrosion results from the exposure of the blank metal to air after disassembly of the actuator.

The shrinking at cryo is likely to have caused increased friction and therefore affected the lifetime significantly. The lubricant used—Dicronite—showed significant signs of abrasion after life testing (about 330,000 motor revolutions), resulting in metal-to-metal contact as well as a major increase in necessary current; according to ECSS, a clear failure of life test.

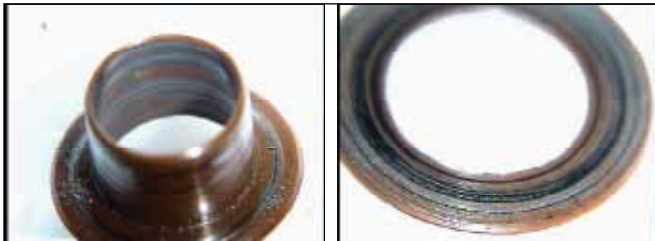
Figure 12—Pre-QM1 Vespel SP1 bushing and distance washer after life test.

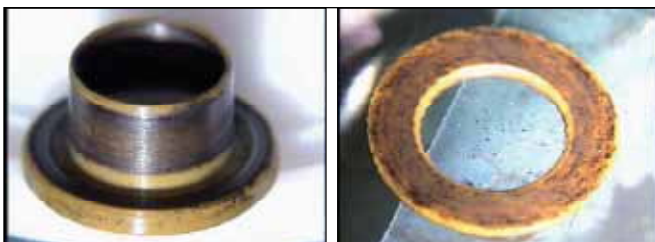
Figure 13: Pre-QM1 Torlon bushing and distance washer after life test.

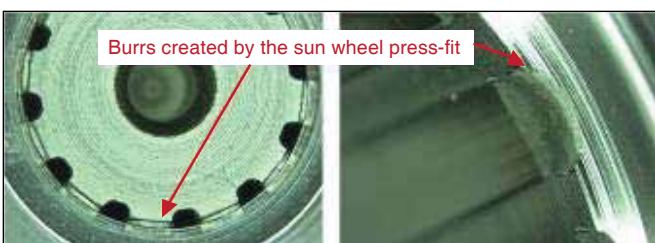
Figure 16—Failed pressing trial results.

To replace the Cronidur, the planet carriers have been manufactured from titanium. Extensive trials have been performed to identify the necessary oversize for press fit. By doing so, the required torque loading is transmitted to the sun wheel on the one hand—but not to exceed the ultimate strain of about 7% of titanium (Figs. 16–17). As for the gearbox housing, a material substitution has been widely discussed with many experts, but the number of materials in the same CTE range of Cronidur is very limited.

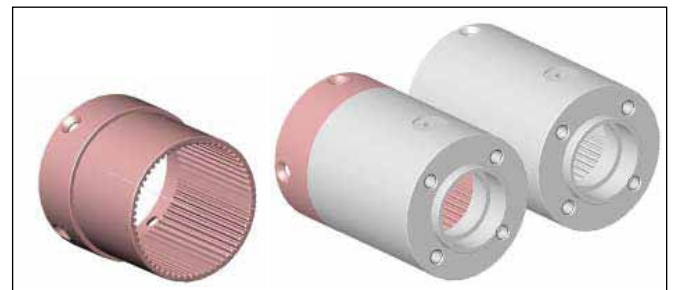
Figure 18—Hollow-wheel ring and integrated design versus gearbox housing made entirely of Cronidur.

- Hardening the entire gearbox housing (Fig. 18, right)
- Manufacture a hollow-wheel ring from Cronidur (Fig. 18, left), harden it and assemble it in an

integrated design to a titanium housing (Fig. 18, middle)

Both methods have been tested; the entire gearbox and hollow-wheel ring have been subsequently hardened and 3-D-measured with this result: the hollow wheel was ovalized but the gearbox remained *stable*.
