Investigations of Bearing Failures Associated with White Etching Areas (WEAs) in Wind Turbine Gearboxes

Robert Errichello, Robert Budny and Rainer Eckert

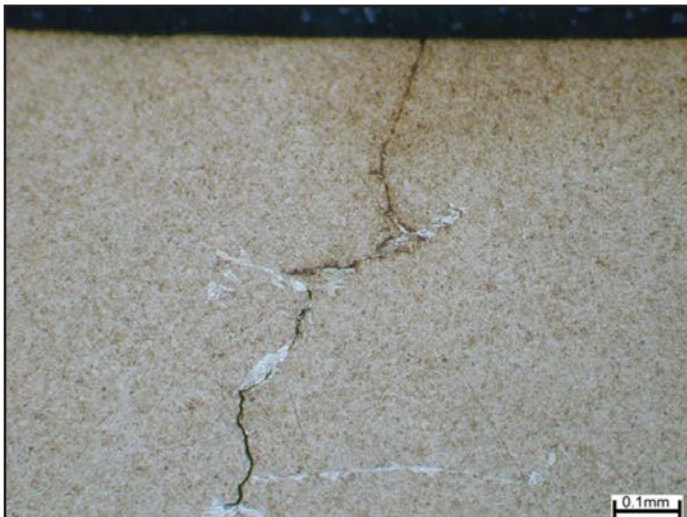
Figure 3 Irregular white etching areas on axial crack.

The authors' experience shows that through-hardened bearings display irWEAs on axial cracks that propagate radially through the bearing IR section (Fig. 3), whereas carburized bearings display irWEAs on crack networks that occur over large, subsurface areas at depths ranging from near the surface to the depth of the maximum shear stress (Fig. 11). Eventually the cracks reach the surface, where they form macropits; this is consistent with the findings of other investigators (Refs. 16, 20, 22). This failure mode is sometimes known as "white structure flaking (Ref. 21)."

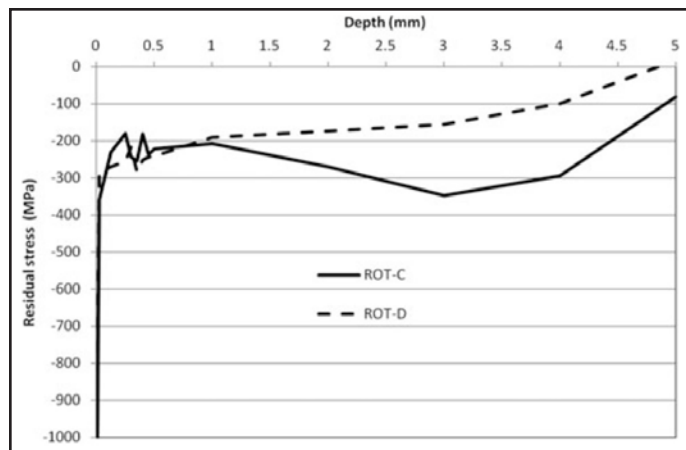
Residual stresses and retained austenite were measured on new, unused rotor bearings. Figure 9 shows residual stresses on rotor bearings determined by XRD, per ASTM E915. The residual stresses for the ROT-C and ROT-D bearings are entirely compressive to a depth of $500 \mu\text{m}$. For depths below $20 \mu\text{m}$, the residual stress for the ROT-D bearing is -250 MPa near the surface, and it fades to zero IMPa at a depth of $500 \mu\text{m}$; whereas the residual stress for the ROT-C bearing increases from -250 MPa near the surface to a maximum of -350 MPa at a depth of $300 \mu\text{m}$ and fades to -100 MPa at a depth of $500 \mu\text{m}$.

Figure 9 Residual stresses for rotor bearings.

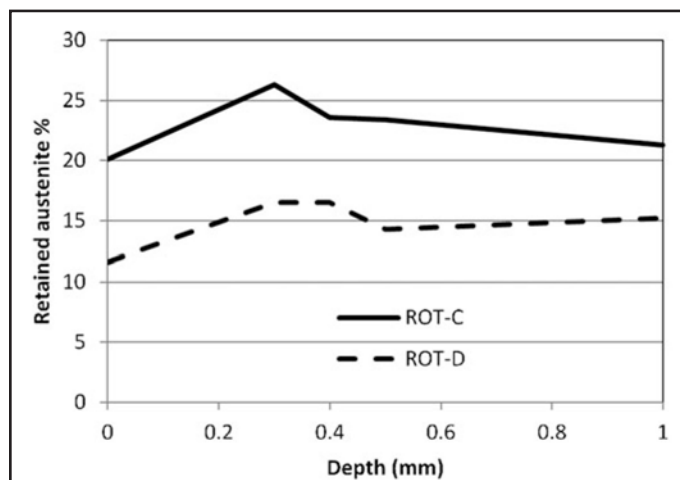
Figure 10 shows retained austenite on rotor bearings determined by XRD, per ASTM E975. The retained austenite for the ROT-D bearing ranges from 12 - 17%; the retained austenite for the ROT-C bearing ranges from 20 - 26%.

Figure 10 Retained austenite for rotor bearings.

Carburized rotor bearings. Tables 3 and 4 show that the ROT-C and ROT-D rotor bearings have similar geometries and chemistries. Yet Figure 10 shows that the ROT-C bearings have a significantly greater amount of retained austenite — at *all* depths. Furthermore, metallurgical analyses of non-failing bearings have shown that no irWEAs form in the ROT-C bearing, whereas irWEAs form in the ROT-D bearing at depths ranging from 400 to 600 μm (Fig. 11). Figure 9 shows that the residual stresses for the ROT-C and ROT-D bearings are very similar at the depths of the irWEAs. In summary, the carburized rotor bearings ROT-C and ROT-D have similar macrogeometries, chemistries, and residual compressive stresses — *but different levels of retained austenite*. There are also differences in the design roller profiles between the two bearings, and analysis of the profiles predicts higher peak stress for the ROT-D profile under many operating conditions. Furthermore, coordinate measuring machine (CMM) measurements made on actual components suggest that the as-built roller geometry of ROT-D bearings results in even higher peak stress under many operating conditions than do the nominal profiles. It is therefore believed that the better performance of ROT-C bearings is due to their higher amount of retained austenite, superior roller profile design, and reduced variation in manufacturing.

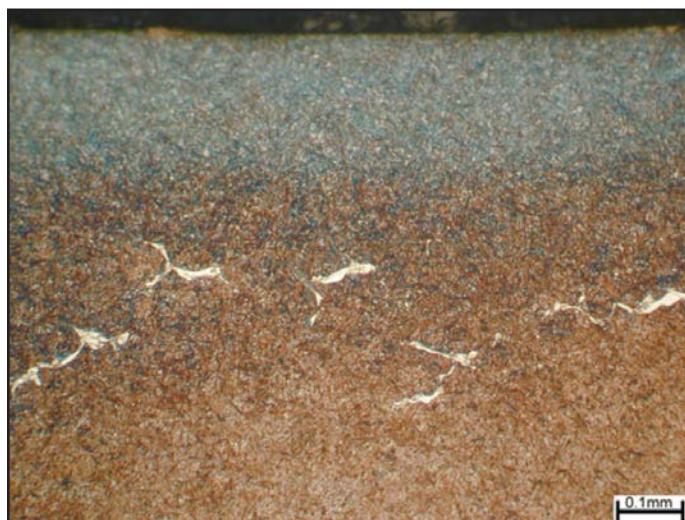
Two non-failing rotor bearings (a ROT-C and a ROT-D) were removed from service after 25,000 h and metallurgically examined. The ROT-C bearing had butterflies at depths ranging from $100 - 400 \mu\text{m}$, but *no* irWEAs. The ROT-D bearing had numerous irWEAs at depths ranging from $400 - 600 \mu\text{m}$ (Fig. 11).

Figure 11 irWEAs on rotor bearing ROT-D IR.
