University Improves Sustainability OF HVAC Motors IN Platinum LEED Building

Introduction

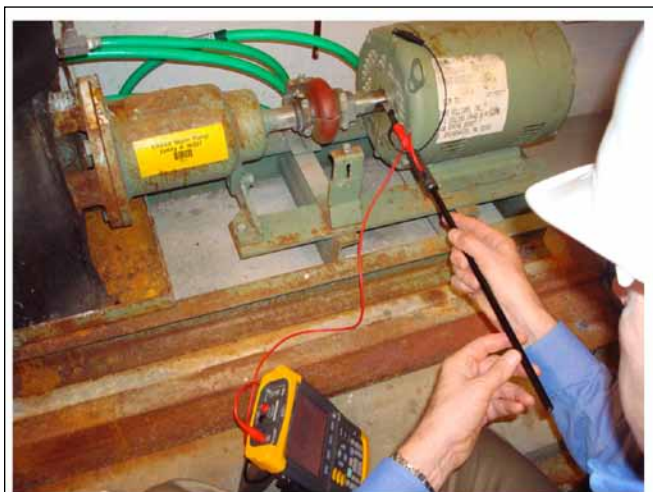
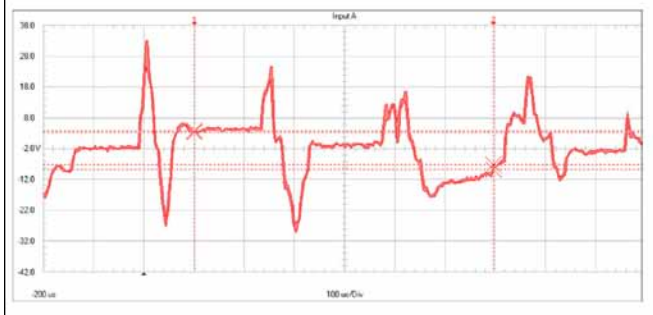
Figure 1 – Motor #1 powers a chilled water pump with the VFD set at 60 Hz and motor running at 1,776 rpm (7.2 amperes).

Motor No. 1. Before the grounding ring was installed on Motor No. 1, the shaft guard was removed. With the VFD set at 60 Hz, the motor was running at 1,776 rpm (7.2 amperes). When a voltage probe was held against the motor shaft, the oscilloscope (set at 10 volts and 100 microseconds-per-division) indicated peak-to-peak discharges of 61 volts. The oscilloscope display showed rapid voltage collapses at the trailing edge of the waveform—typical of the electrical discharges that damage bearings.

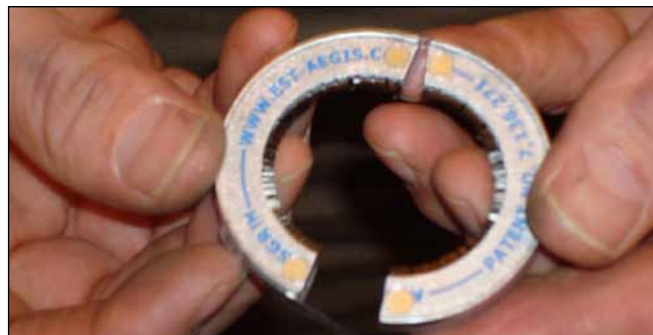
Figure 2—Equal proportions of epoxy and activator are mixed and small amounts are applied to the back of the ring.

Equal proportions of epoxy and activator were then mixed, and small amounts were applied to the back of the ring.

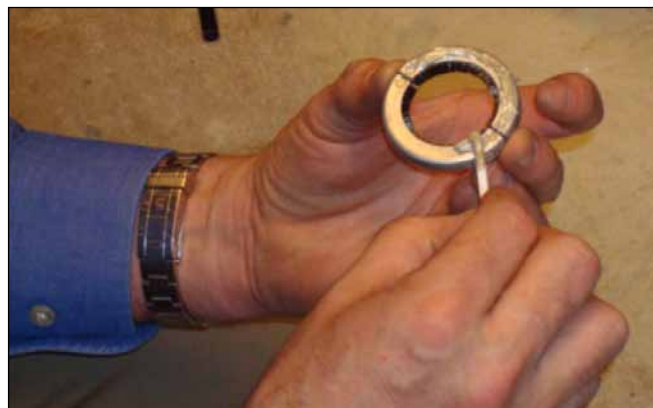
Figure 3—Narrow band of Aegis colloidal silver coating is then applied around the shaft to improve surface conductivity. Ring is then installed on the shaft and re-taped.

Prior to installing the ring, a narrow band of Aegis colloidal silver coating was applied around the shaft where the fibers contact it, to improve the surface conductivity. The ring was then installed on the shaft and re-taped.

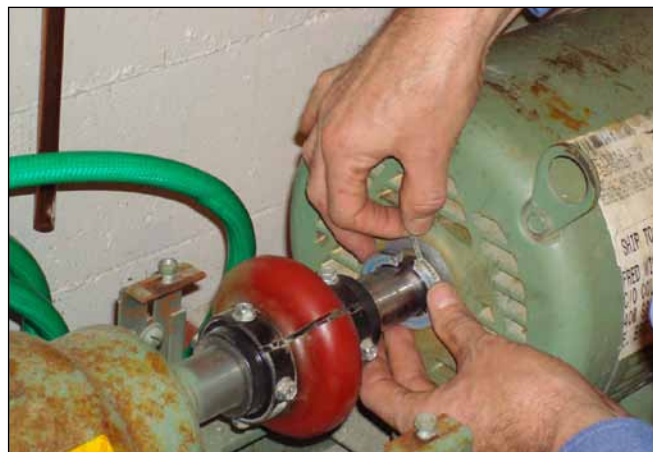
Figure 4—Ring is pushed back against bare metal of end-bracket, maximizing electrical contact via conductive epoxy. To ensure ring is correctly centered on shaft, metal spacers (included in the kit) are inserted into gaps between two halves of ring. Post adhesive cure, spacers are removed. Installation time: about 10 minutes.

Next, the ring was pushed back against the bare metal of the end bracket, maximizing electrical contact via the conductive epoxy. To ensure that the ring was correctly centered on the shaft, small metal spacers (included in the kit) were inserted into the gaps between the two halves of the ring. Once the adhesive cured, the spacers were removed. The entire installation took about 10 minutes.

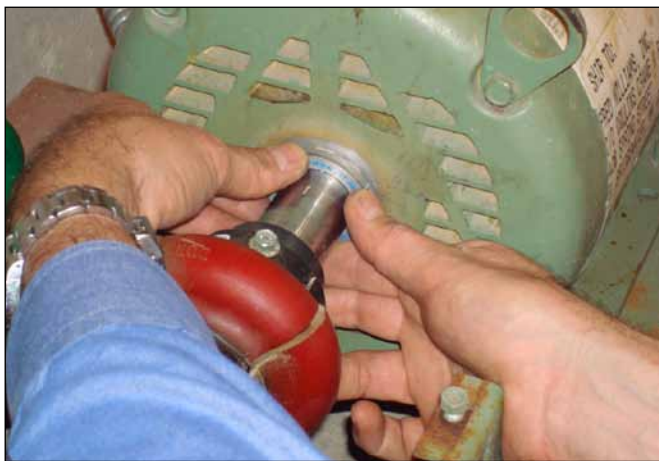
Figure 5—One hour after installation, epoxy has cured and motor again tested with oscilloscope and probe. Now—with VFD set at 60 Hz; motor running at 1,775 rpm (7.4 amperes); and oscilloscope set at 10 millivolts and 100 microseconds-per-division—discharge plot displayed on scope is essentially a straight line, indicating shaft voltage discharges were diverted by Aegis ring to ground.

Approximately an hour after installation the epoxy had cured sufficiently to allow testing of the motor again with the oscilloscope and probe. This time, with the VFD set at 60 Hz, the motor running at 1,775 rpm (7.4 amperes), and the oscilloscope set at 10 millivolts and 100 microseconds-per-division, the discharge plot displayed on the scope was essentially a straight line—indicating that shaft voltage discharges were being diverted by the Aegis ring to ground.

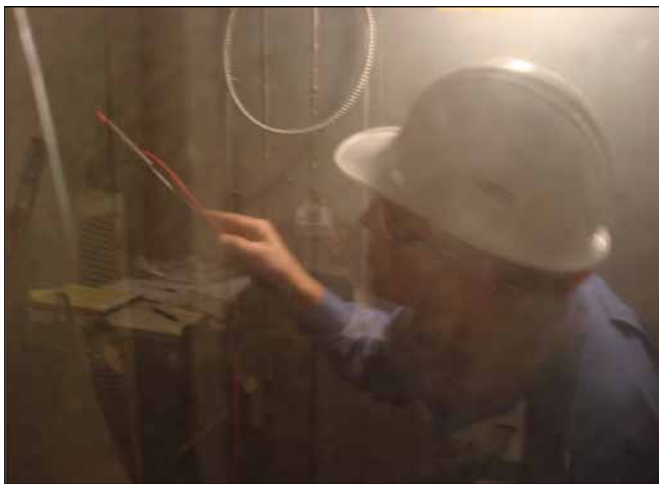
Figure 6—Unlike Motor #1, the Motor #2 shaft is difficult to reach, with only a couple of inches between the end-bell and a sheave exposed; the versatility of the splitting Aegis SGR and ease of installation using conductive epoxy become even more apparent.

The shaft was cleaned and prepared in the same manner as that used for Motor No. 1, but because the motor shaft was difficult to reach and only a couple of inches of it between the end-bell and a sheave were exposed, the versatility of the splitting Aegis SGR and the ease of installation using conductive epoxy became even more apparent—and necessary.

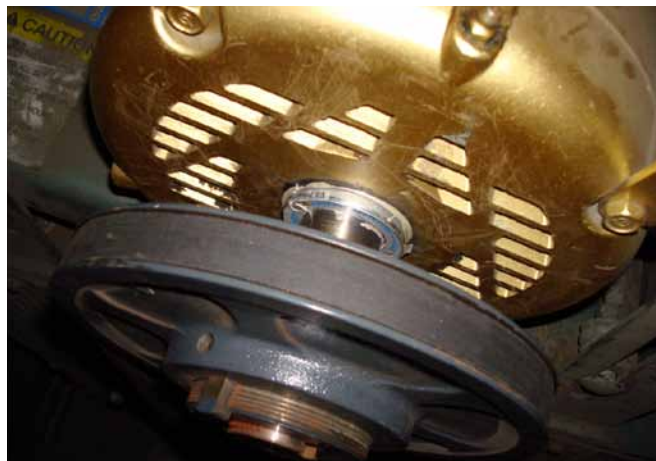
Figure 7—Hand-held heater is used to speed epoxy's cure; post-curing, shaft voltage is measured again, showing a reading of only 380 millivolts, peak-to-peak.

A hand-held heater was used to speed the epoxy's cure, and about a half-hour after installation, the shaft voltage was measured again. This time the reading was only 380 millivolts, peak-to-peak.

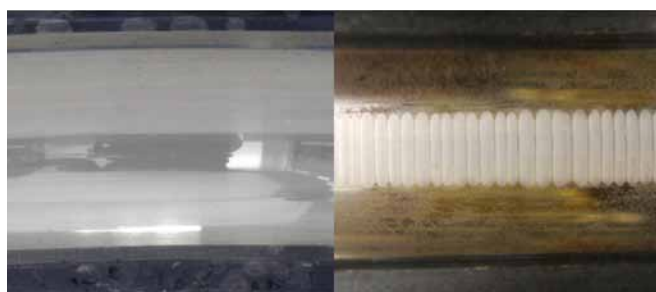
During virtually every VFD cycle, these induced currents discharge from the motor shaft to the frame via the bearings, leaving small fusion craters in ball bearings and the bearing race wall that eventually lead to noisy bearings and bearing failure. In a phenomenon called fluting, the operational frequency of the VFD causes concentrated pitting at regular intervals along the bearing race wall, forming washboard-like ridges. Fluting can cause excessive noise and vibration. In an

Figure 8—New bearing (left); fluted bearing (right).

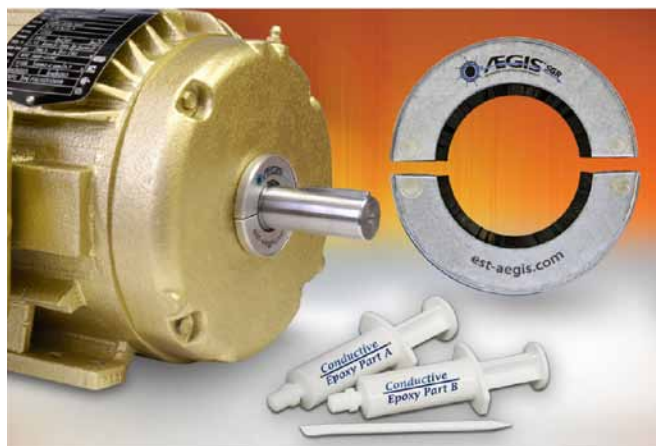
Figure 9—Aegis grounding ring requires no maintenance and lasts for life of motor, regardless of rpm.

Once installed, the Aegis grounding ring requires no maintenance and lasts for the life of the motor—regardless of rpm. Test results show surface wear of less than 0.001" per-10,000-hours of continuous operation and no fiber breakage after two million direction reversals.
