# Force Control

## Assists in Helicopter Transmission Overhaul

Force Control Industries

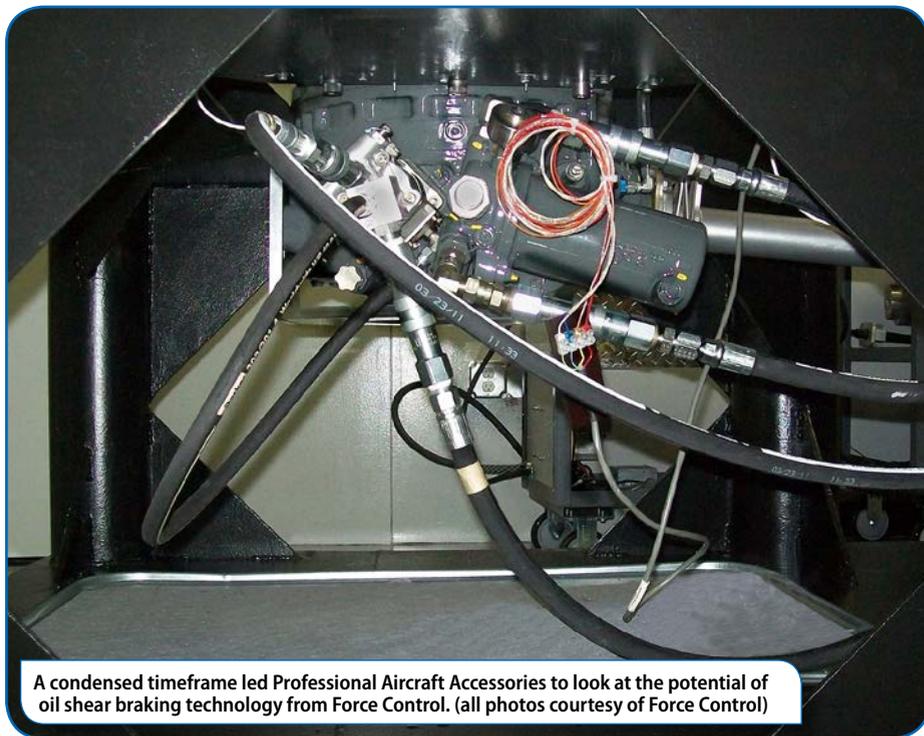
A condensed timeframe led Professional Aircraft Accessories to look at the potential of oil shear braking technology from Force Control. (all photos courtesy of Force Control)

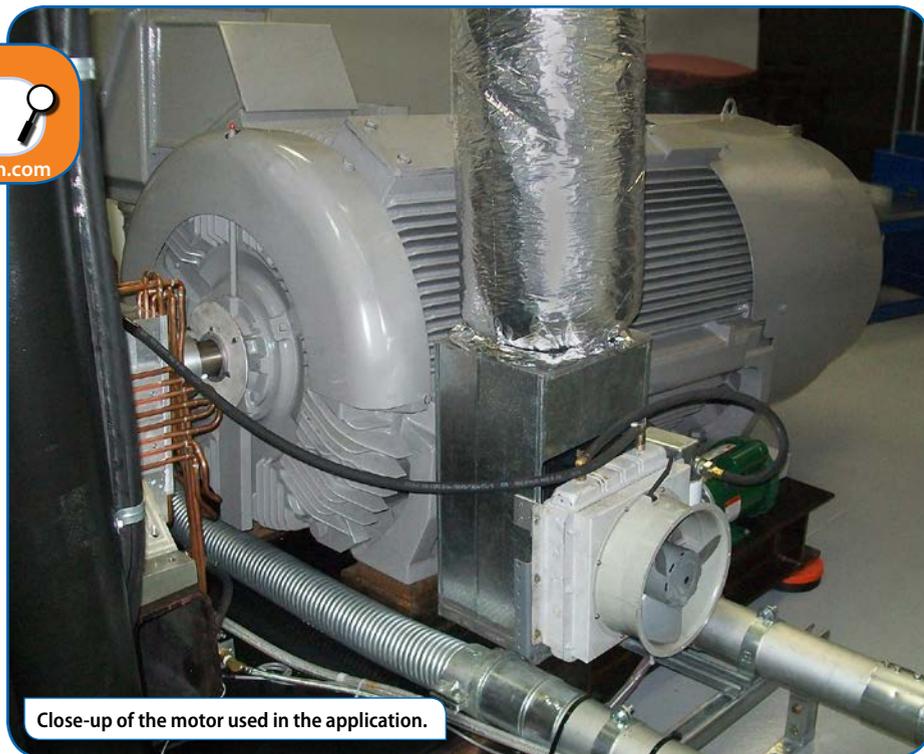
Close-up of the motor used in the application.

Power is supplied via a General Electric (GE) electric motor and variable frequency drive (VFD) combination with 700 horsepower and 3,600 rotations per minute. The specification calls for testing at 40- 60- 80- 100- and 112 percent of load for various timeframes.

Leach and the team specified components from various sources, the GE motor and VFD, the skid mounted brake and cooling system from Fairfield, Ohio based Force Control Industries, and a 1.7:1 gearbox to reach the 6000 rpm needed. They used LabView software from National Instruments

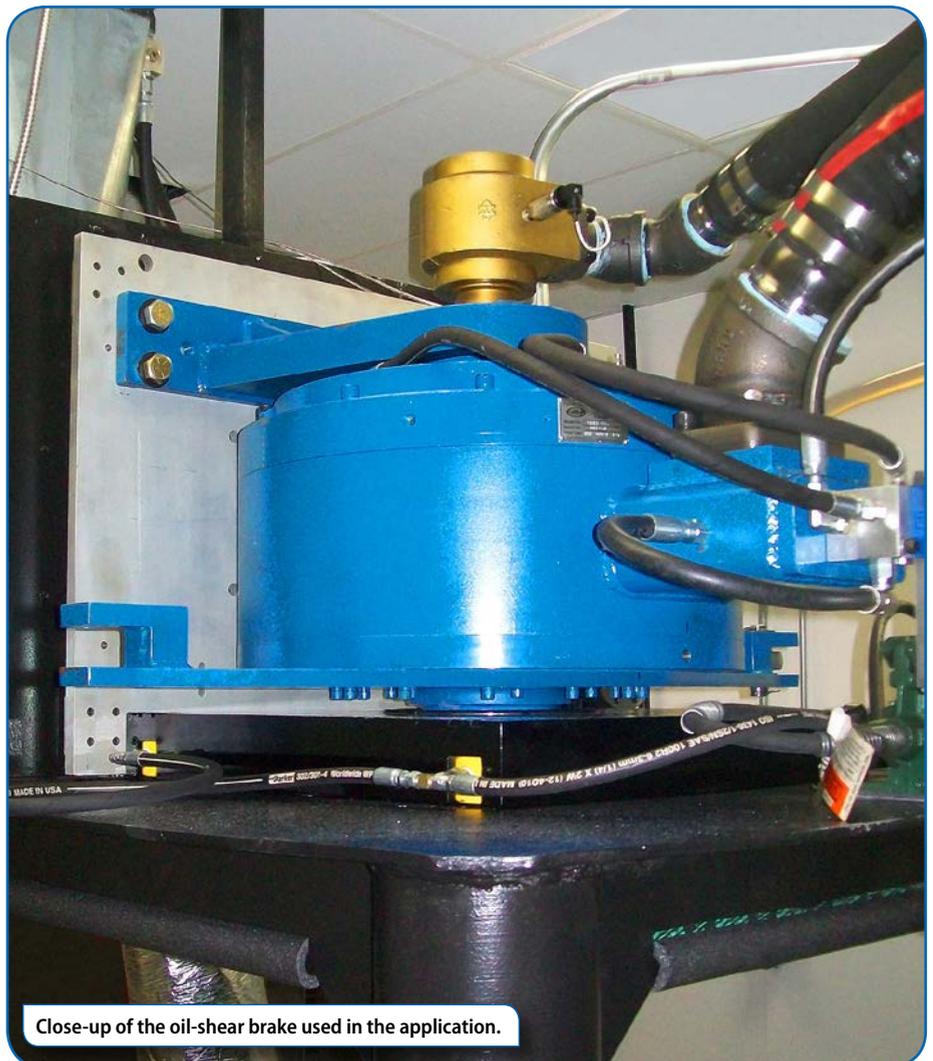
Close-up of the oil-shear brake used in the application.

Load is supplied by a TB 83 oil shear brake from Force Control Industries which can be precisely controlled to meet the various spec points.

To dissipate the heat generated by that amount of torque, the oil shear brake came equipped with a patented forced lubrication and cooling system. In addition, the heat exchanger circuitry also has components to safeguard against viscosity changes as the oil changes temperature. The cooler the oil, the thicker it gets. To safeguard against overloading the pump, which moves 250 gallons of oil per minute across the brake, heating elements are installed to keep the oil at a fairly consistent temperature. A programmable logic controller (PLC) monitors the temperature and controls the heating elements.

While the system was designed for vertical operation the brake was mounted horizontally to allow direct torque measurement. Force Control officials didn’t foresee a problem doing so, but an air pocket was created

which caused the friction disc to burn up, since it was not fully wetted. A fast and effective solution was suggested and implemented, allowing PAA to

a fluid film flows between the friction surfaces, the fluid is compressed as the brake is engaged. The fluid particles in shear transmit torque to the other side. Since most of the work is done by the fluid particles in shear, wear is virtually eliminated.
