# Premature Bearing Failures in Wind Gearboxes and White Etching Cracks

Kenred Stadler and Arno Stubenrauch

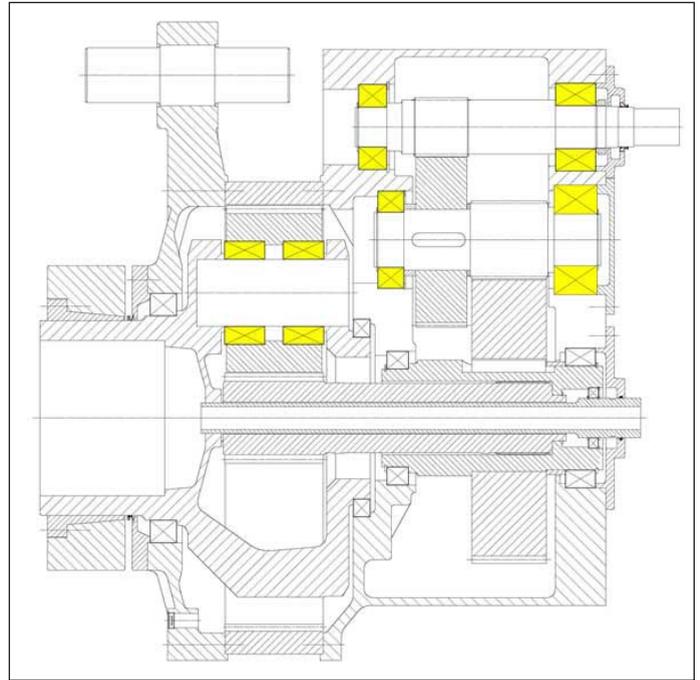
Figure 1 Standard multi-megawatt (MMW) wind gearbox (for 3-point suspension) having a low-speed planet stage and two spur wheel sections (high-speed intermediate shaft and high-speed shaft) with highlighted bearing locations that can be affected by premature bearing failures.

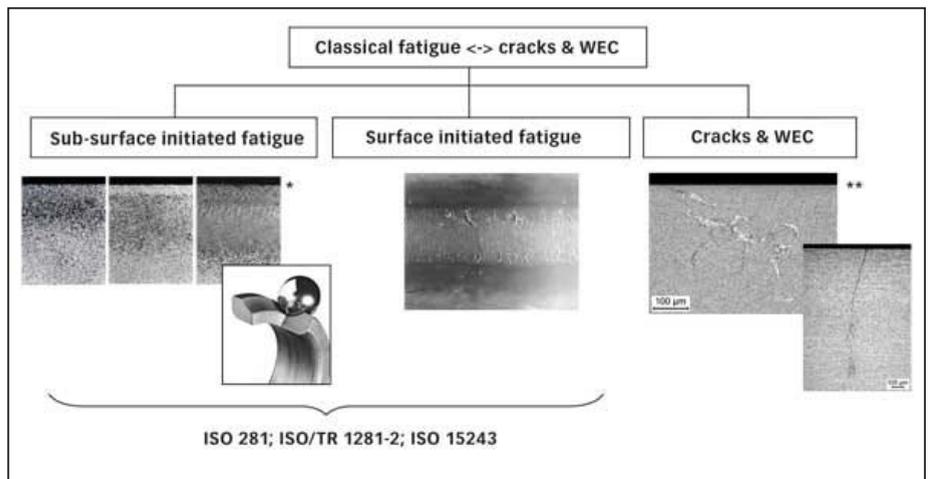
Much premature wind gearbox bearing damage results in a failure mode that is not caused by the classic rolling contact fatigue (RCF) mechanisms (Fig. 2). While these classic mechanisms are sub-surface-initiated fatigue — as well as surface-initiated fatigue — and can be predicted by standard bearing life calculation methods (see ISO 281 and ISO/TR 1281-2), premature crack failures are not covered by these methods.

Figure 2 Classic fatigue failure modes vs. cracks and WEC \*micrograph, according to Reference 5, \*\*micrograph according to Reference 6.

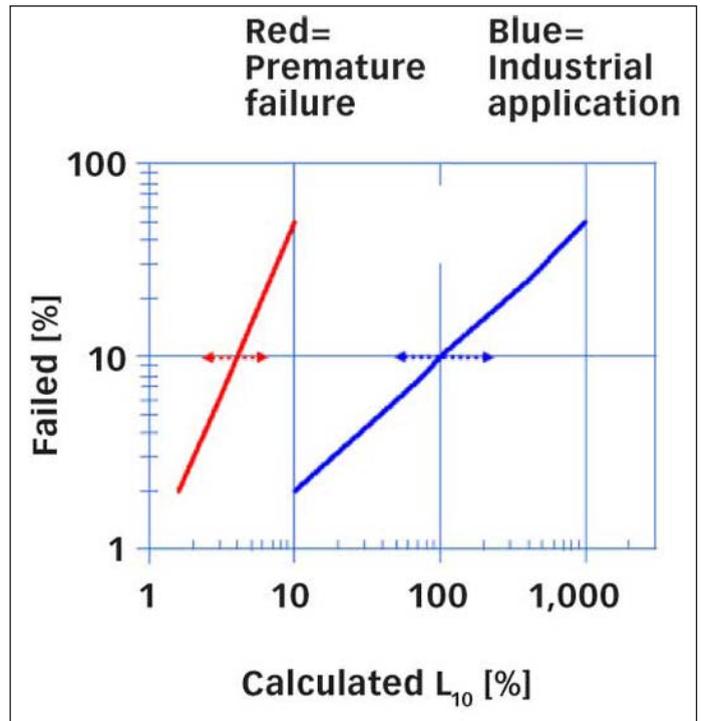
marine propulsion systems, crusher mill gearboxes or lifting gear drives, in wind applications the frequency of premature failures seems to be higher (but might also be related to a larger population of installed machines). Commonly, early cracks have occurred within the first one to three years of operational time or at 5 to 10 % of the calculated rating life (Fig. 3).

Figure 3 Typical in premature failing of industrial machinery is that bearings from identical machines in the same specific surroundings are failing within a consistent and short time period. The slope difference is a predictor of “other than classic fatigue.” Those having had a short service life are likely to have a short service life again if no further actions on the bearing-shaft-housing system are taken.

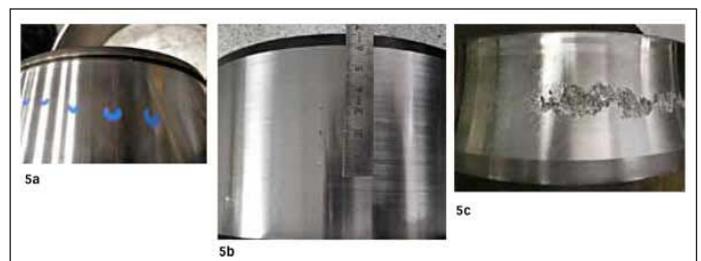
Mostly occurring on the inner ring (Fig. 4), the visual appearance of early cracks varies from straight or “axial cracks” to cracks in combination with small spalls and large/heavy spalling. Based on SKF’s knowledge gained through increased field experience, it is concluded that early failures by cracks are neither linked to a particular type of bearing (Fig. 5), nor to a particular standard heat treatment (Fig. 6; Refs. 6 -10).

Figure 5 Examples of typical bearing types that can be affected: a) tapered roller bearing; b) cylindrical roller bearing; and c) spherical roller bearing.

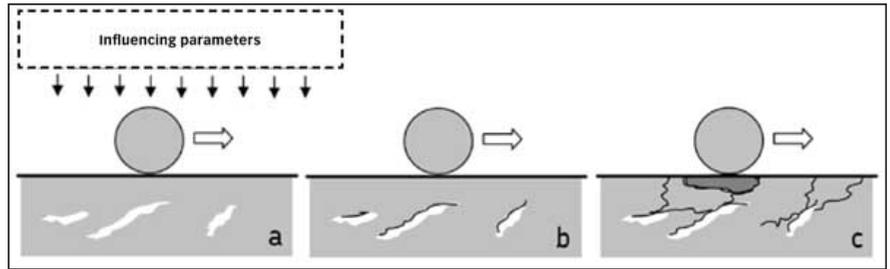
Figure 7 According to existing theories in the literature, a) certain influencing factors locally change the microstructure into white etching areas (WEAs); b) WEAs will be the starting points of white etching cracks (WECs); and finally, c) white structure flaking (WSF) due to crack propagation reaches the bearing raceway.

Nevertheless, many of the existing theories from literature can be briefly summarized (Fig. 7). Many papers (for example, Ref. 10) discuss a local change in the bearing material microstructure into WEC by certain influencing factors.

Thus, driven by a single factor or by a combination of several factors, WEAs develop locally in the bearing steel matrix. The WEAs will then be the nucleation sites of cracks that finally propagate to the bearing raceway. As a consequence, the bearing will fail by spalling or so-called WSF.

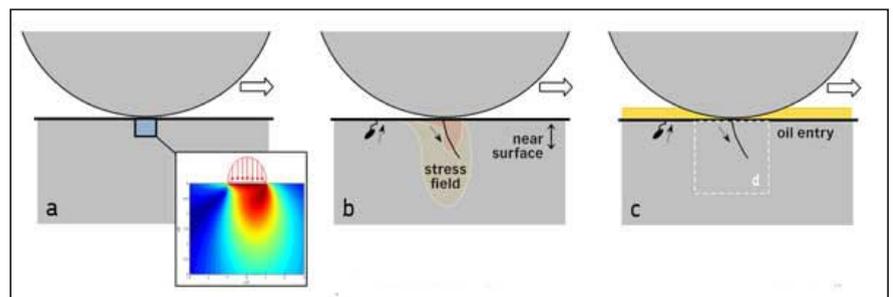
Figure 8 (A) Roller-raceway contact with areas of local high traction due, for example, to local mixed friction, leading to tensile stresses that can, b) lead to damage such as a small crack; c) surface crack or crack connected to the raceways allows the entry of oil; (for "area d" details, see Fig. 12).

As schematically shown in Fig. 8, transient conditions can trigger surface cracks, possibly accelerated by tribochemical effects 6, 16, 39, 40, 41, or sub-surface cracks that reach the raceway when starting at weak points such as inclusions close to the surface (<150 μm) 6.

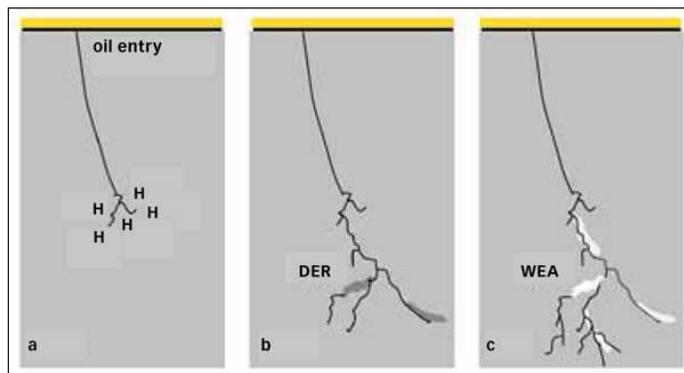
Once the bearing raceway is locally damaged, the highly EP doped lubricant will penetrate into the crack. Depending on the crack orientation, hydraulic effects will additionally push the crack propagation 46. As indicated in Fig. 12, the lubricant (often aged and/or contaminated with water) will react inside the material at the fresh metallic crack flanks. In other words, a corrosion fatigue crack propagation process, CFC, is triggered.

Inside the crack system, the mechanism of CFC will then transform the microstructure locally into white etching areas and lead to the typical appearance of an irregular WEC network (e.g., Figs. 2, 6, 14). Thus, WECs are considered as secondary; a by-product of the CFC mechanism, as the hydrogen released and energy dissipated at the crack flanks result in a local change of the microstructure then appearing as a white etching crack decoration.

Figure 12 (Continuation of Fig. 8): a) After penetration, oil and additives react in the crack flanks locally, producing hydrogen — b and c; the hydrogen transforms locally the microstructure close to the crack system into white etching cracks WECs (from dark etching regions (DER), to white etching areas, WEAs) 6, 7, 16.
