The Hidden Cost of Incomplete Hydrodynamic Bearing Maintenance

Will Cannon, Application Engineer, Baldor Electric Company

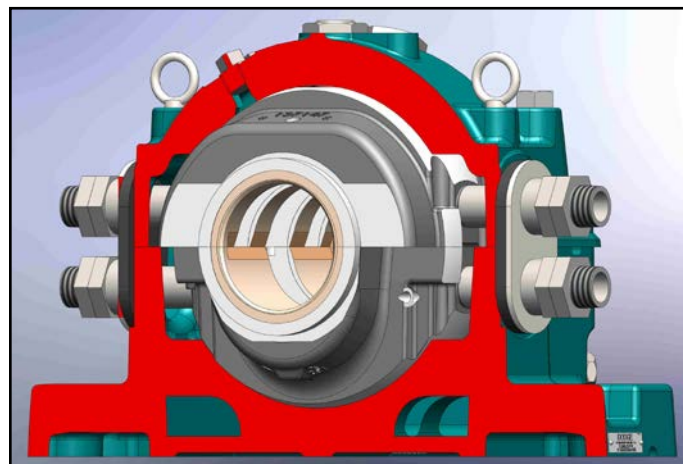
Before an entire fan refurbishing is planned, it is a common maintenance practice to service the unit and its components to optimize the fan performance and to complete corrective actions for the issues that have developed. Unfortunately, during the stress and time-sensitive nature of outages, planned or unplanned, the predominant corrective action of hydrodynamic bearing maintenance when vibration levels have exceeded their limits is to replace the liner (insert) of the bearing, and to leave the housing untouched and uninspected (Fig. 1).

Figure 1 Cutaway view of a pillow block assembly showing the liner, which is commonly serviced, and the housing, which is commonly neglected of service. (Courtesy of Dodge)
