# Novel Steel Grade Resists Fatigue as Life Becomes Harder for Bearings

Dr. Tania Loaiza Uribe and Dr. Mikael Thunman

Finding new steel grades with robust fatigue properties is becoming increasingly important for heavy vehicles. A key driver is the accelerating trend towards electrification that imposes additional loads on the powertrain.

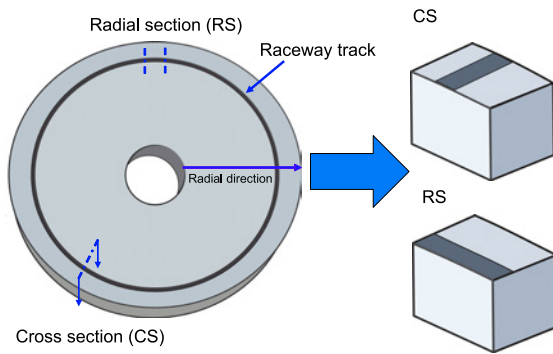
**Figure 2**—The circular contact track formed after the RCF test is shown as a dark grey line. The red line and arrow indicate the circumferential and radial sections before cutting. The extracted circumferential and radial section samples with the contact track are also shown.

Following the RCF test, samples were extracted from areas both parallel (circumferential-section) and transverse (radial-section) to the rolling direction (see Figure 2). The samples were ground and polished in preparation for microscopic inspection. For the circumferential-section care was taken to polish until the center of the microstructural decay region was reached. For both materials, the virgin microstructure and the microstructural decay were examined using scanning electron microscopy (SEM) and electron backscatter diffraction (EBSD).

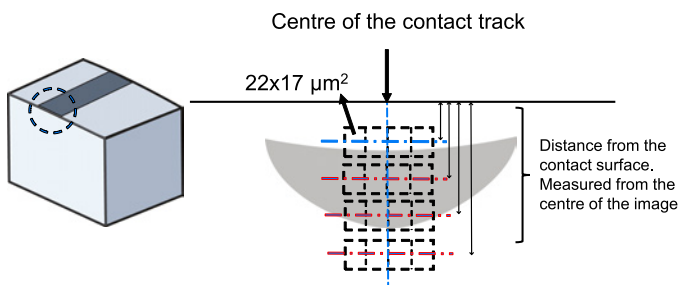
**Figure 3**—The sample orientation for determining the area fraction of microstructural decay in the radial section sample. The schematic indicates the size, number and position of the SEM images.

Four high-resolution images were obtained at four different depths (50, 75, 100, and 125  $\mu\text{m}$ .) for each material, with each image size being  $22 \times 17 \mu\text{m}^2$  (see Figure 3).

For the analysis, 374 grid points were used in each image to calculate the area fraction of material decay on the radial section of the raceway track. Figure 3 illustrates the configuration and the position of the images.

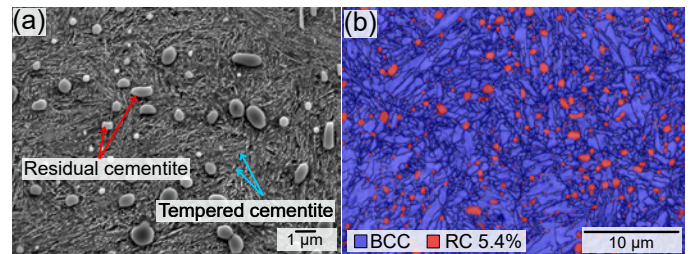
**Figure 4**—52100 virgin material. (a) SEM/SE micrograph showing tempered cementite and RC. (b) EBSD image quality and phase map overlaid showing martensite in grey (94.6 percent) and RC in red (5.4 percent).

Figure 4(a) shows the SEM image of the as-heat-treated virgin sample of 52100 steel. The steel has a martensitic structure with the average diameter of RC determined to be  $0.72 \pm 0.22 \mu\text{m}$  with an aspect ratio of  $1.58 \pm 0.39$ . The volume percentage of RC determined from the EBSD phase map is  $5.40 \pm 0.42$ , see Figure 4(b). The image analysis using the SEM micrographs indicates that the volume percentage of tempered cementite is about 15 percent.

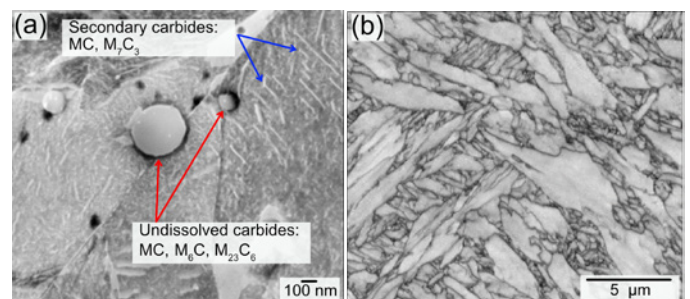
**Figure 5**—Hybrid Steel 60 virgin material. (a) SEM/SE image showing secondary carbides and undissolved carbides within the martensitic microstructure. (b) EBSD image quality map showing martensite laths.

The as-heat-treated microstructure of Hybrid Steel 60 is shown in Figure 5(a)(b), it comprises lath martensite, Figure 5(a)(b), secondary carbides such as MC and  $\text{M}_7\text{C}_3$  (plate-like carbides), NiAl intermetallic precipitates, and a small number of undissolved precipitates MC,  $\text{M}_2\text{C}$ , and  $\text{M}_6\text{C}$ .

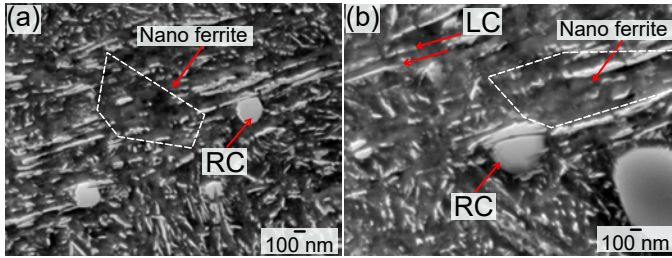
**Figure 6**—SEM/SE imaging of decay in 52100 steel after RCF in the CS at 80  $\mu\text{m}$  from the contact surface. (a) Decay at  $1.0 \times 10^8$  stress cycles, tempered carbides dissolution, nano ferrite patches, residual cementite decay. (b) Residual cementite decay, by ferrite intersecting the carbides, surrounded by nano ferrite patch.

The microstructural decay observed in the region of maximum shear stress (40–130  $\mu\text{m}$ ) in 52100 steel after testing is shown in Figure 6(a)(b). Here, the original martensite laths disappear combined with dissolution of residual cementite and tempered carbides. The disappearance of the martensite laths is related to the formation of ferrite microbands and nano-sized ferrite, as shown by the enclosed dotted white line. Figure 6(b) shows the decay of RC, where the accumulation of dislocations at the RC interface induces partial dissolution of the cementite. The figure also shows that the elongated ferrite penetrates the cementite. No tempered cementite is observed near and within the elongated ferrite and ferrite microband, indicating the tempered cementite has been dissolved.

The reason for the drop in hardness in 52100 at the region of maximum shear stress is that this steel experiences higher cyclic softening due to the dissolution of cementite, including both residual and tempered cementite. This is illustrated in Figure 6(a)(b). This process occurs through the intersection of residual cementite by elongated ferrite, as well as the accumulation and interaction of dislocations at the interface between the cementite and the matrix. This aligns with findings from various previous researchers, which suggest that the binding energy between carbon atoms and the dislocation core is greater than the bonding between carbon and iron atoms in cementite.

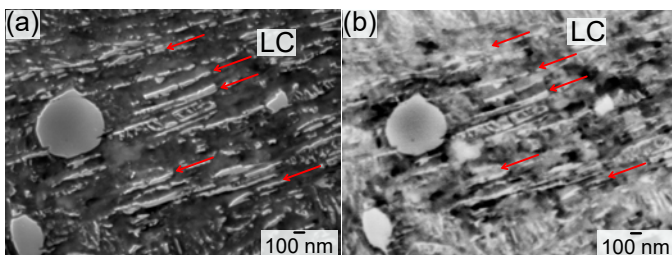
**Figure 7**—Microstructural decay in 52100 steel after RCF at  $1.0 \times 10^8$  stress cycles in the CS, at 40–130  $\mu\text{m}$  from the contact surface. (a) SEM/SE image reveals the presence of LC, indicated by yellow arrows. (b) SEM/BSE image of the same area as (a), bright contrast (yellow arrows) indicated the presence of LC.

During the initial stages of RCF, the emergence of lenticular cementite adjacent to elongated ferrite was detected. The bright contrast of the lenticular cementite resembles the tempered cementite observed in SEM/SE imaging but other than the contrast, the lenticular cementite (LC) varies in size, alignment, and position compared to the tempered cementite. Further proof is presented in Figure 7(a)(b), and has also been shown in previous research.

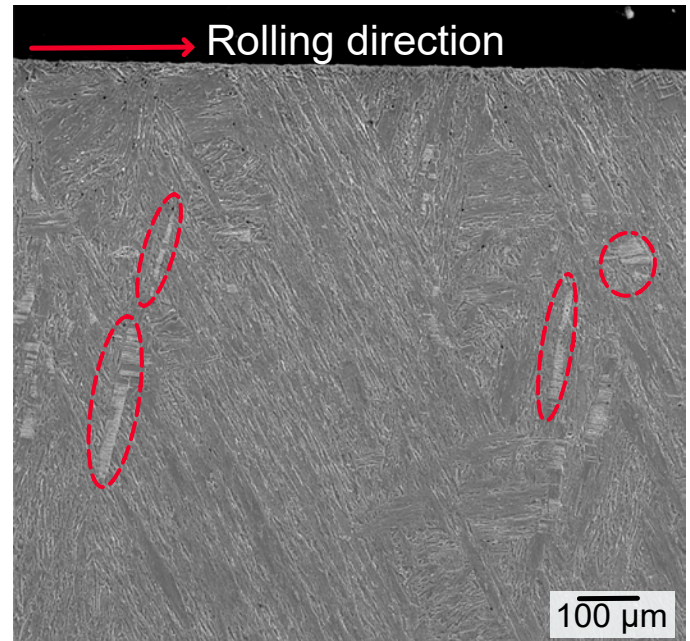
**Figure 8**—Microstructural decay of Hybrid Steel 60 was observed in the CS and close to the contact surface after RCF at  $1.0 \times 10^8$  stress cycles; the red ovals highlight the decayed microstructure (ferrite microband).

Figure 8(a)(b) shows a lower magnification image of the microstructure in Hybrid Steel 60. The microstructural decay is indicated by the ellipses with a red dashed line. Not all martensitic laths contain ferrite microbands after RCF, which indicates ferrite microbands mainly form in preferred crystal orientations during RCF, i.e., in the martensite lath that is favorably oriented concerning the stress exerted during RCF.

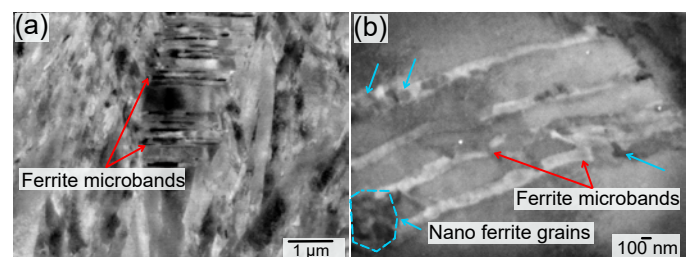
**Figure 9**—The microstructural decay of Hybrid Steel 60 after RCF, at  $1.0 \times 10^8$  stress cycles in the CS, obtained at a depth of 60  $\mu\text{m}$  from the contact surface with SEM/BSE imaging. (a) Ferrite microband formation across martensite lath. (b) Nano ferrite grains + ferrite microbands. This sample is not etched.

Figure 9(a)(b) shows the formation of parallel bands within martensite laths known as ferrite microbands. Some nano-sized ferrite grains are also formed adjacent to the ferrite microbands. The ferrite microbands have a size of  $150 \pm 28$  nm and appear to form within the martensite laths that are favorably oriented for slip.

Figure 9(b) shows that the tempered martensite is replaced by the formation of ferrite microbands and nano ferrite grains (encircled with the yellow dashed line). The microstructure decay observed here is similar to that found during RCF in the 52100 steel, which the rearrangement of dislocations can explain due to cyclic microdeformation.

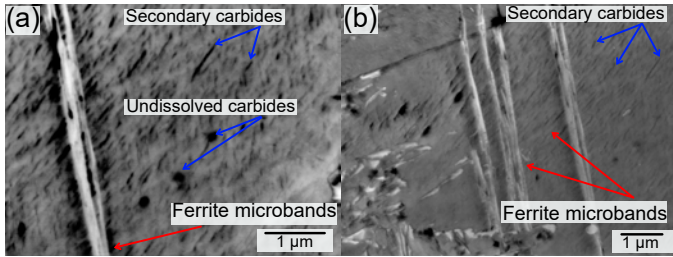
**Figure 10—Microstructural decay in the Hybrid 60 steel in the CS at a depth of 60 µm beneath the raceway surface. (a) SEM/BSE image of ferrite microbands, surrounded by secondary carbides. (b) SEM/SE image of secondary carbides.**

Figure 10(a)(b) illustrates the presence of secondary carbides within the martensite laths, as well as ferrite microband formation in Hybrid Steel 60 after RCF. The results show that the secondary carbides remain undissolved within the martensite lath region close to the ferrite microband, indicating their high mechanical stability. This is the critical factor for the material's high decay resistance. Alloy carbides exhibit high thermodynamic stability, making them less susceptible to dissolution due to dislocation movement and variations in dislocation density.

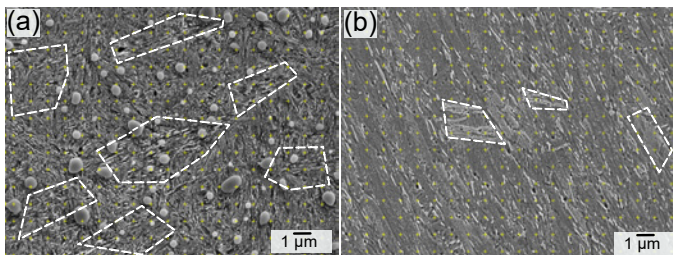
**Figure 11—SEM/SE image of microstructural decay in the region of maximum shear stress after  $1.0 \times 10^8$  stress cycles, in the radial section at 75 µm from the raceway surface. (a) 52100 steel. (b) Hybrid Steel 60.**

A comparison of the different microstructural decay is shown in Figure 11a-b and Figure 12a.

In Figure 11, the area encircled by the dashed white lines shows examples of decayed microstructure. In these areas, elongated ferrite, ferrite microband, and nano-sized equiaxed ferrite can be observed.

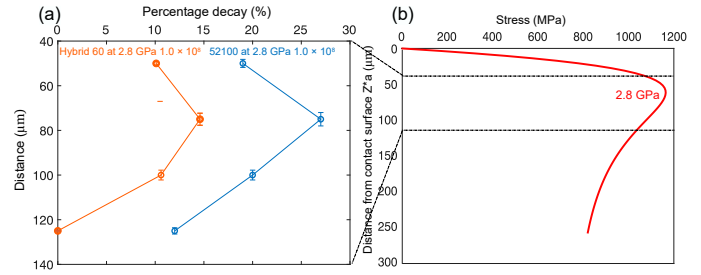
**Figure 12—(a) The effect of distance from the surface on the percentage of microstructural decay for 52100 steel and Hybrid Steel 60. (b) The calculated shear stress along the center line of rolling contact. Region of maximum shear stress is indicated.**

Figure 12(a) shows the change in the area percentage of microstructural decay from the contact surface toward the interior of the sample. The shear stress distribution across the depth calculated using Hertz theory is also shown in Figure 12(b).

The microstructural decay increases with the depth from the surface, having a maximum value between the depths of 75 and 100 µm, where the Hertzian stress is the highest during RCF. The percentage of microstructural decay is also higher for 52100 steel than for Hybrid Steel 60.

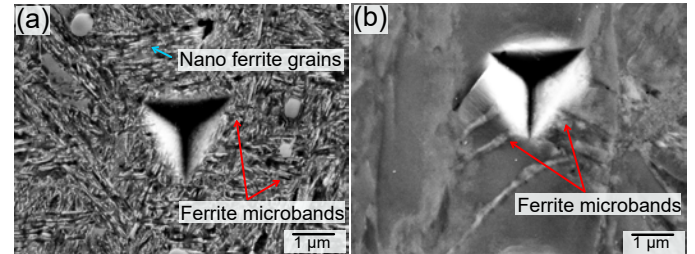
**Figure 13—Nanoindentation in the region of maximum shear stress at  $1.0 \times 10^8$  stress cycles, measured in the radial section sample and at the depth of 75 µm from the raceway surface. (a) SEM/SE image of an indent in the microstructural decay region (yellow arrows) observed in 52100 steel. (b) SEM/BSE image of an indent in ferrite microbands in Hybrid Steel 60.**

Figure 13a shows SE micrographs of the hardness testing indents in the decayed microstructure with elongated and equiaxed ferrite in 52100 steel. These areas have a hardness of around  $7.3 \pm 0.45$  GPa. Figure 13b shows an indent on the ferrite microband within the martensitic lath structure of Hybrid Steel 60 steel. The hardness here is  $9.03 \pm 0.43$  GPa.

The elongated ferrite in the 52100 steel has a lower hardness compared to the virgin matrix ( $8.73 \pm 0.18$  GPa), and the Hybrid Steel 60 has a slightly higher hardness in the ferrite microbands compared with the virgin matrix ( $8.12 \pm 0.19$  GPa).

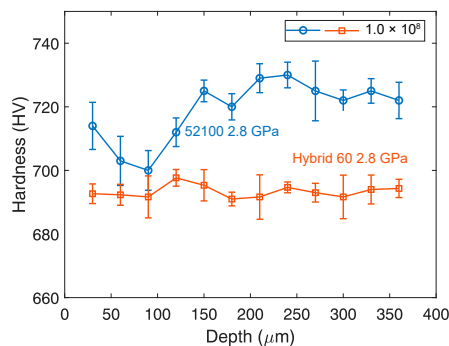
**Figure 14—Micro-Vickers hardness (HV) values obtained from Knoop measurement from the radial section sample after RCF testing for  $1.0 \times 10^8$  stress cycles.**

Figure 14 shows the hardness profile for the two materials after RCF for  $1.0 \times 10^8$  stress cycles. The 52100 steel shows a softening in the region of maximum shear stress (between 40–130 µm from the surface), with a hardness value of  $700 \pm 15$  HV. However, no change of hardness was observed in the region of maximum shear stress for Hybrid Steel 60. This indicates that Hybrid Steel 60 has more resistance toward softening during RCF.
